Fuel line assembly cited in jet fire

Vital mechanism wasn't connected, federal investigators find

By Ken Kaye Staff writer

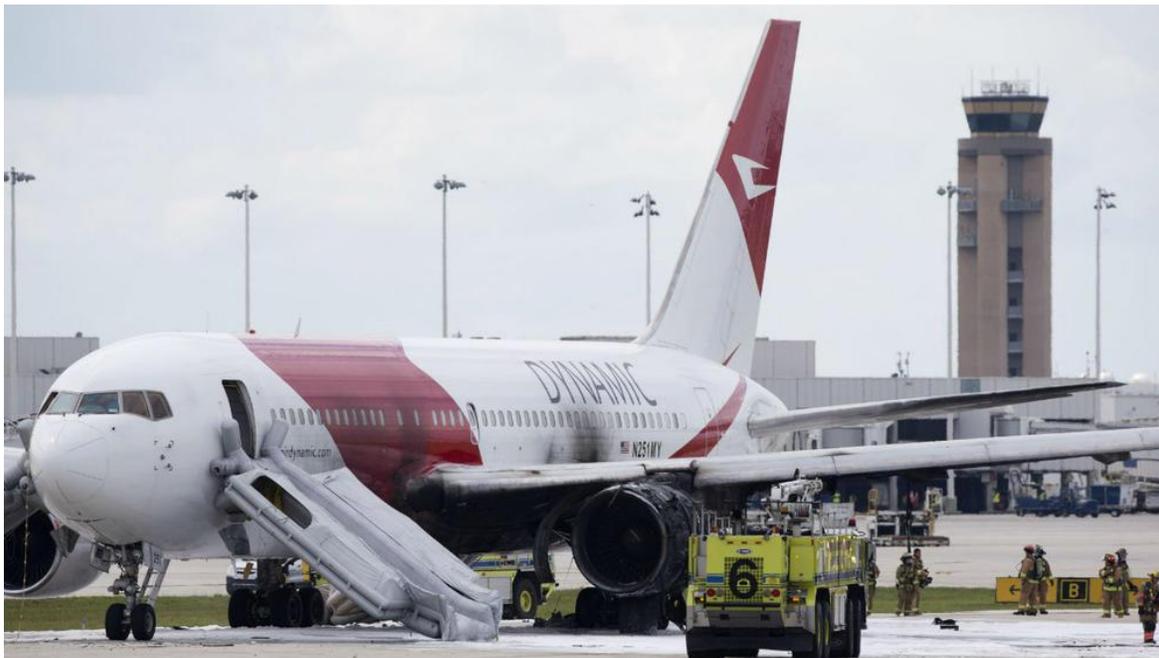
The National Transportation Safety Board says a fuel line component was disconnected before a Dynamic jetliner caught fire last week. AP Photo

Federal investigators have discovered a critical fuel line mechanism was disconnected on the Dynamic International Airways jetliner that caught fire Thursday at Fort Lauderdale-Hollywood International Airport.

- An initial review of the plane’s onboard logbook showed no maintenance had been performed — before the accident — on the wing area where the “fuel line coupling assembly” was found disconnected. That assembly, located just above the engine, has been retained for further examination. There was no evidence the left engine exploded and caused the fire.

- The fire didn’t penetrate into the passenger cabin, but burned the lower portion of the left wing, the left engine and the left side of the fuselage.

- The flight data recorder and cockpit voice recorder are being reviewed at the NTSB’s laboratory in Washington, D.C.
- Dynamic International Airways will inspect the remainder of its planes to ensure “fuel line coupling assemblies,” are properly installed.
